UMATILLA RIVER SUBBASIN FISH HABITAT IMPROVEMENT PROJECT

1991 **Annual** Report

Oregon Department of Fish and Wildlife

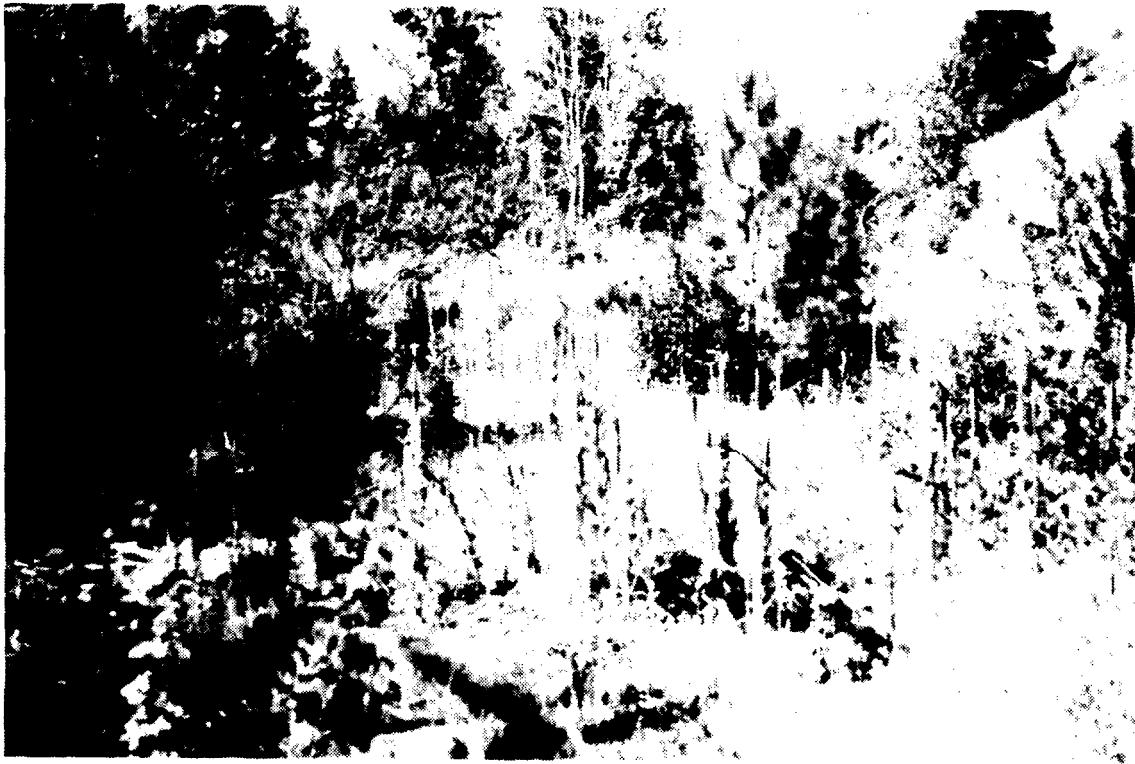
Figure 5. Photopoint 4 on Weatgate Canyon **Creek** Louisiana Pacific property, October 1990.

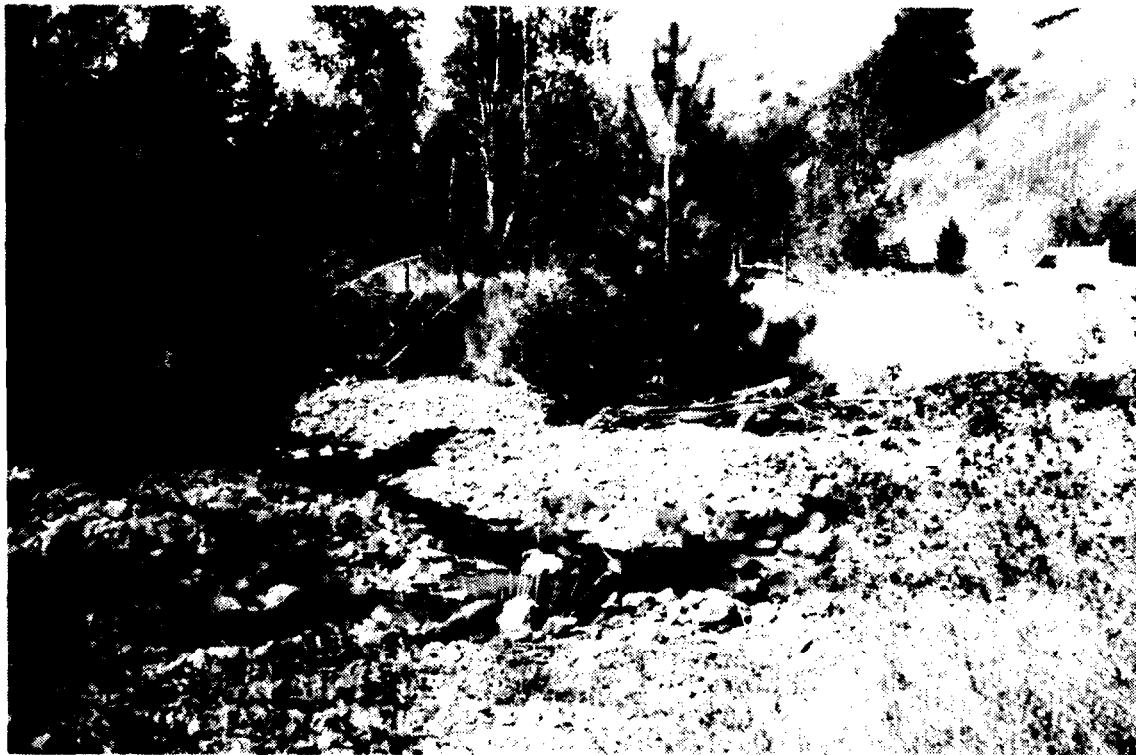
Figure 6. Photopoint 4 on Weetgate Canyon **Creek Louisiana** Pacific property, October' 1991 displaying scour from May 1991 flooding.

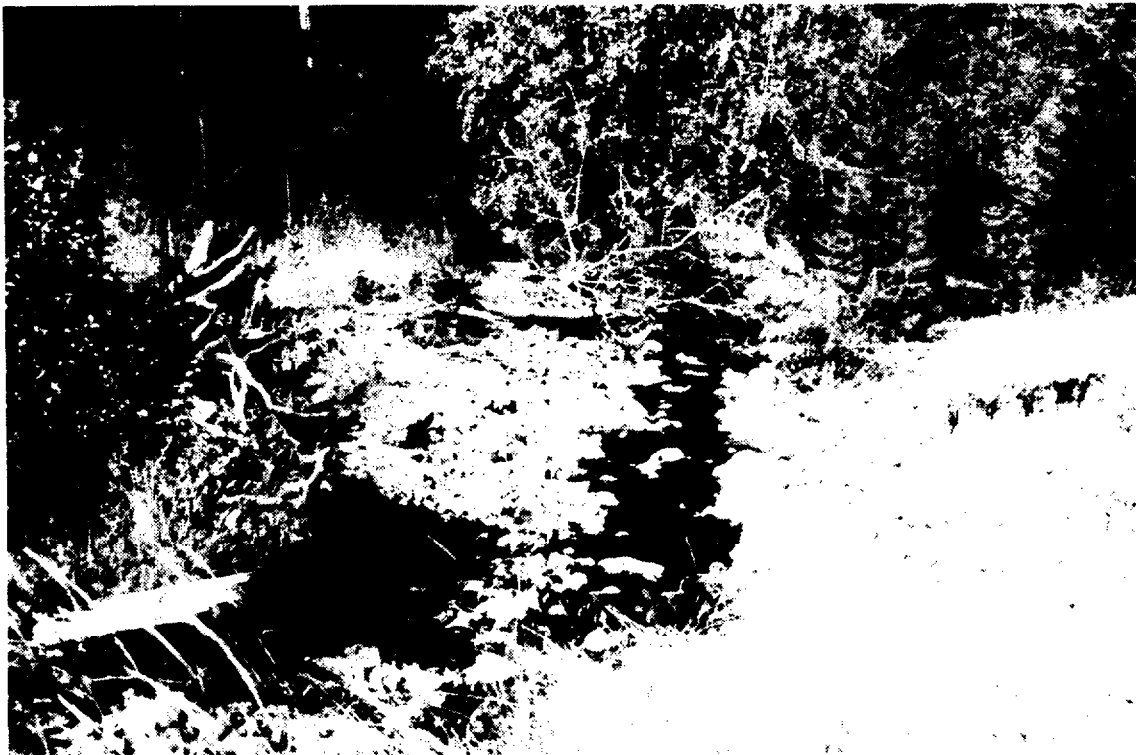
Figure 8. Photopoint 8 on Westgate Canyon Creek Louisiana Pacific property, October 1991 displaying scour from May 1991 flooding.

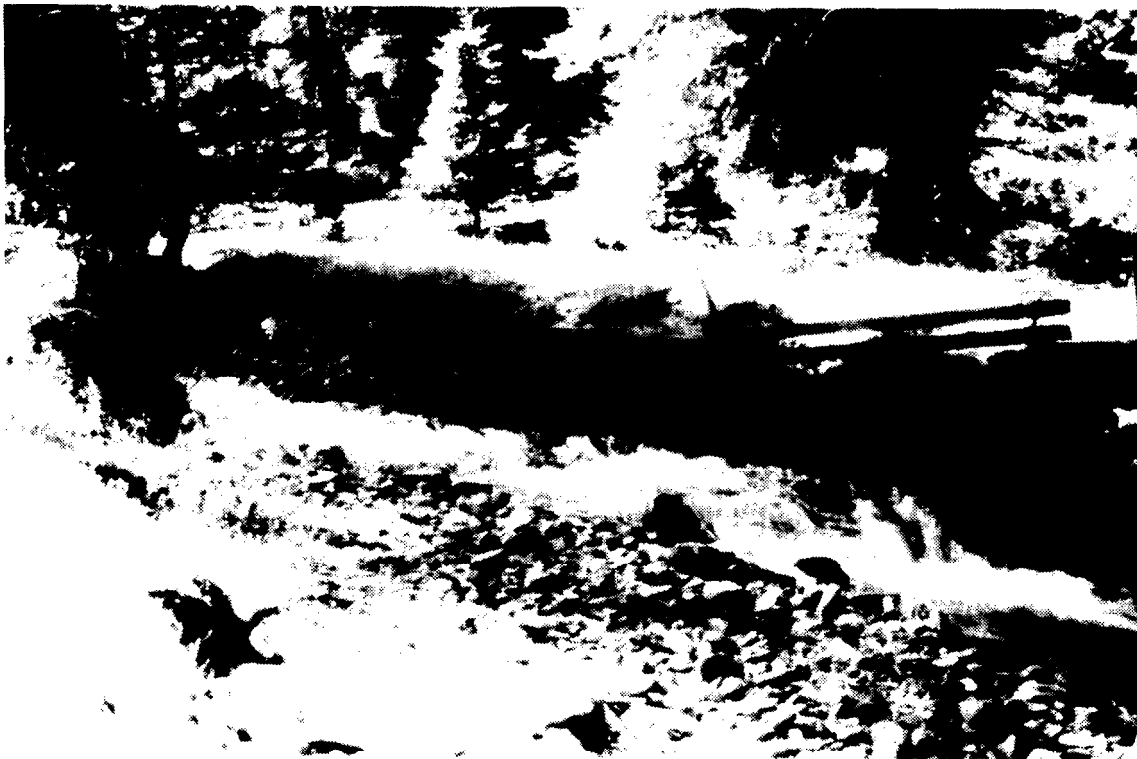
Figure 9. Westgate Canyon Creek stream crossing fence displaying downcutting of channel. Prior to flooding, wood panels were within 12 inches of the water surface.

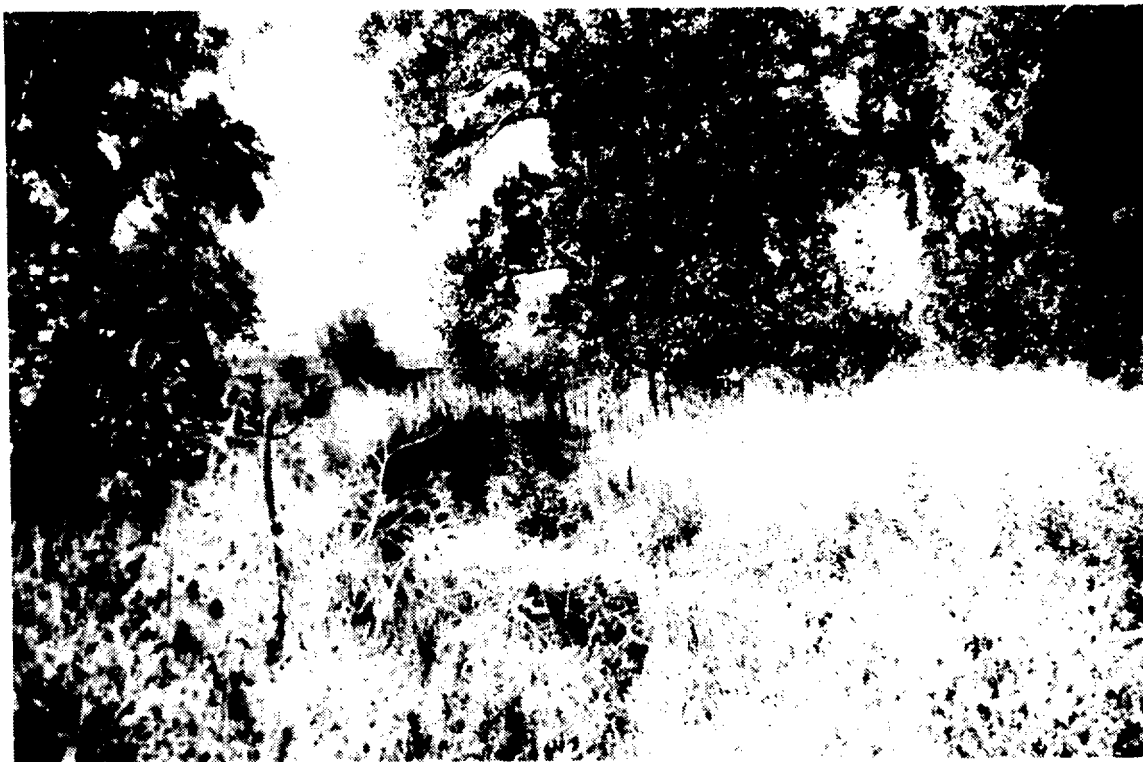
Figure 10. Photopoint 5 on East Birch Creek Houser property, September 1990.

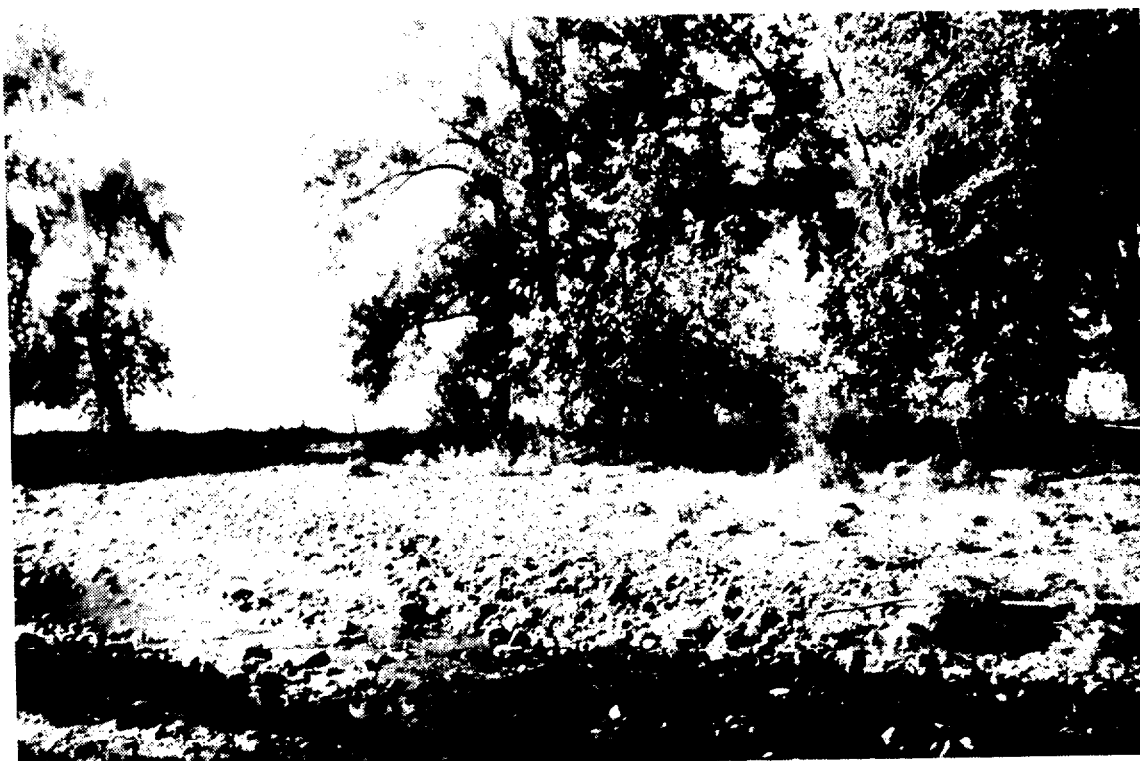
Figure 11. Photopoint 5 on East Birch Creek Houser property, October 1991 displaying scour from May 1991 flood.

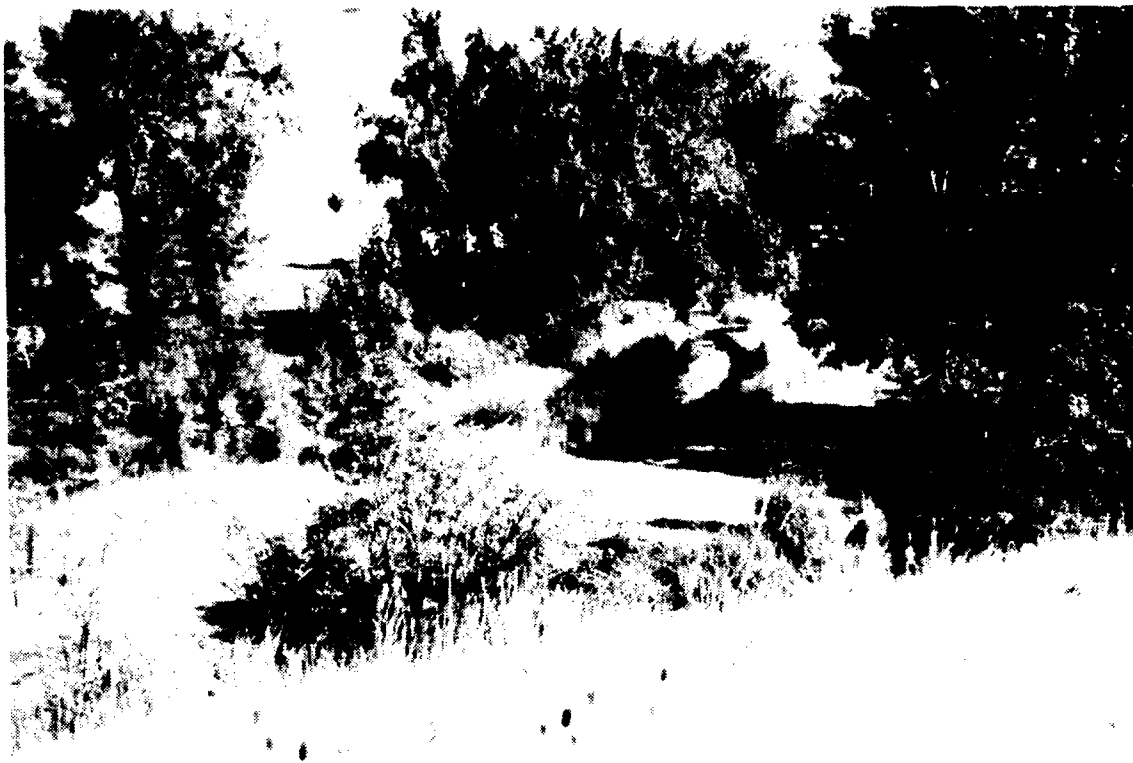
Figure 12. Photopoint 6b on East Birch Creek Houser property, September 1990.

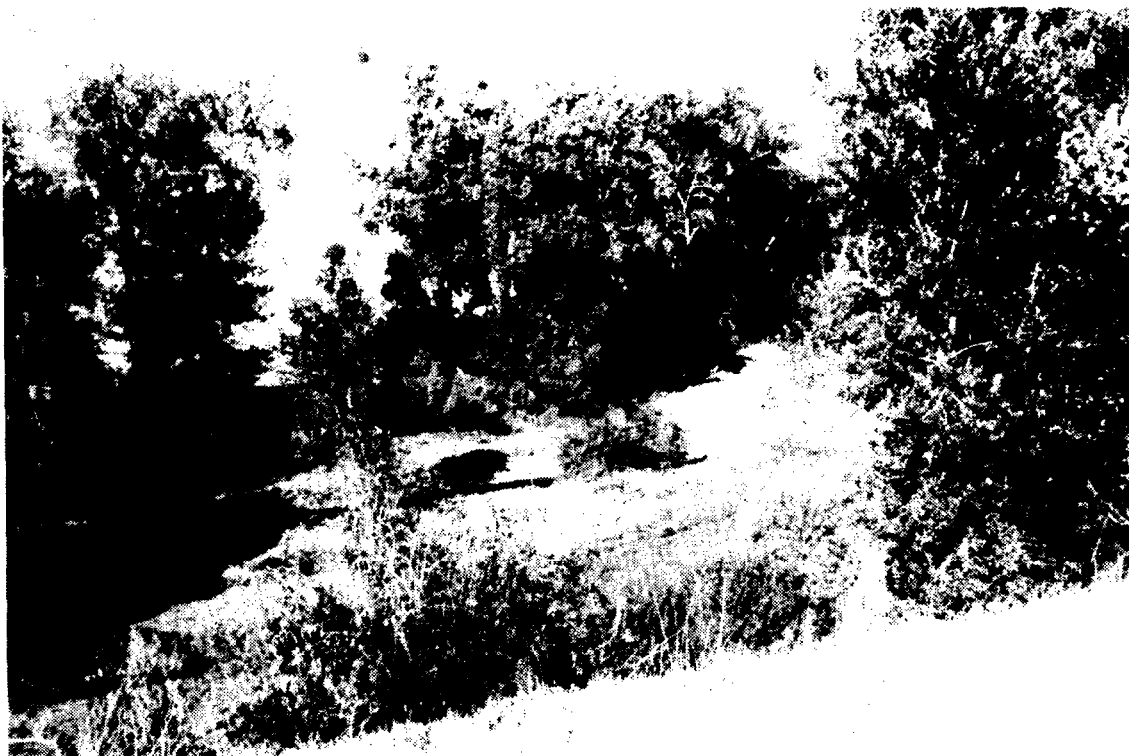
Figure 13. Photopoint 6b on East Birch Creek Houeer property, October 1991 displaying scour from May 1991 flooding.

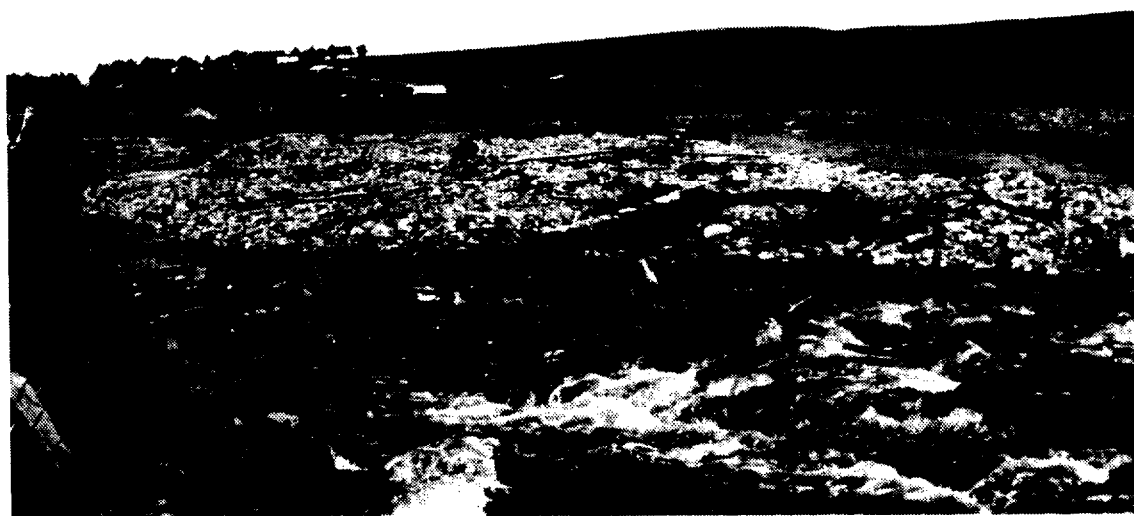
Flood waters totally destroyed the instream work implemented on the "Magic Mile" in 1969. It was determined by T. Bailey and W. Noll that the expenditure of funds necessary to stabilize this section of stream and/or maintain it for the life of the project were not justifiable as costs would far outweigh fisheries benefits. After several meetings with cooperating landowners, the decision was made to replace the active stream channel inside the leased riparian area this year, but that once this year's work was complete, no further instream work would be undertaken by ODFW. The landowners were given the choice of continuing to participate in the program with this understanding. The Britt lease was terminated because a clause in this lease requires ODFW to continue to maintain the channel within the leased area and the landowner's basic discontent with ODFW's position on future instream work. All other participating landowners have chosen, at this time, to remain in the program.

Figure 15. Flood damage on East Birch Creek Snider property (Magic Mile) the week after peak flood flows, May 1991.

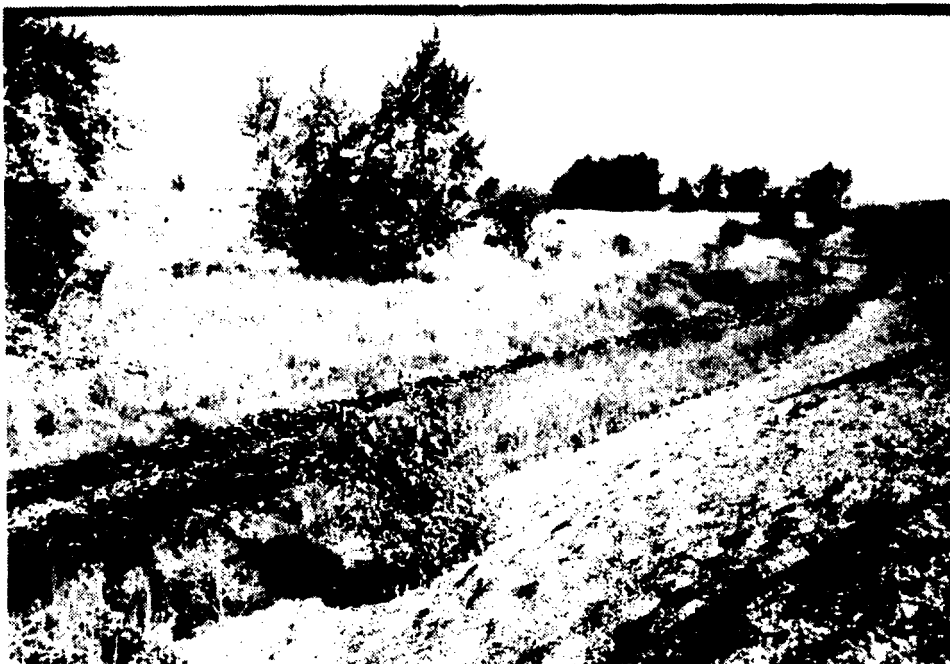
Figure 16. Photopoint 3 on Birch Creek **William** Weinke property, September 1990.

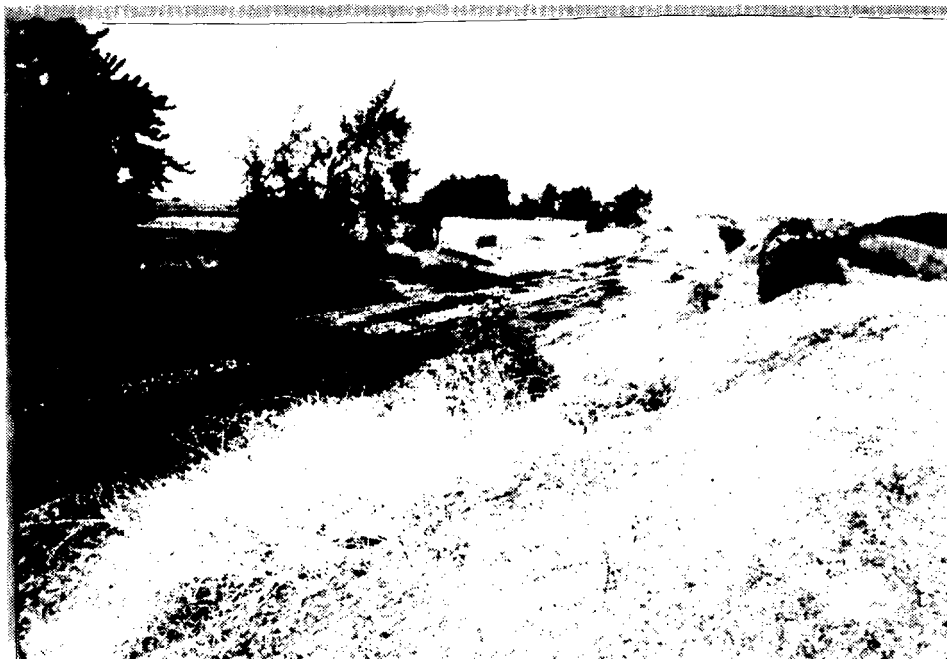
A major fill and removal violation was found to have occurred on the William Weinke property along Mainstem Birch Creek (Figures 16 and 171. Approximately 1,300 feet of stream was channelized without permission from ODFW. Wood Fiber Industries (an adjacent landowner) was found to be responsible for committing the violation. Wood Fiber Industries, as required by DSL, has since worked cooperatively with T. Bailey to develop a five year restoration plan to mitigate for damages. Wood Fiber Industries will pay for and implement the restoration plan.

Figure 17. Photopoint 3 on Birch Creek **William** Weinke property, October 1991 displaying **illegal stream channelization** completed by Wood Fiber Industries.

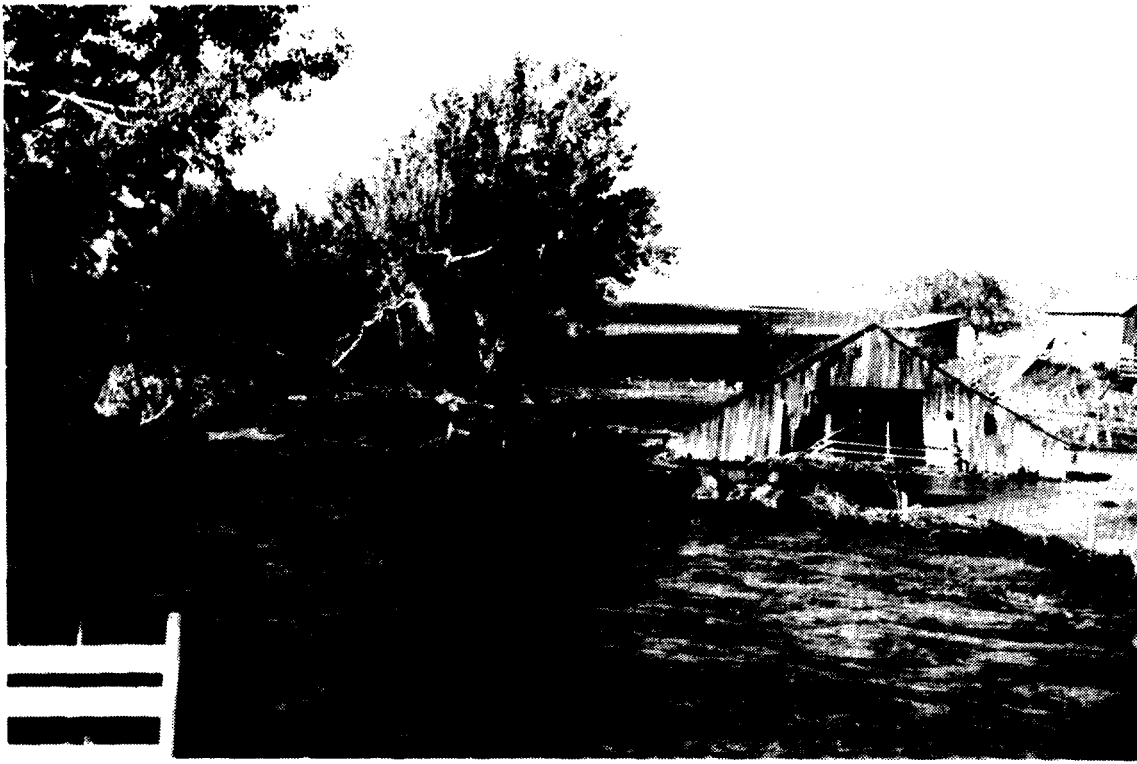
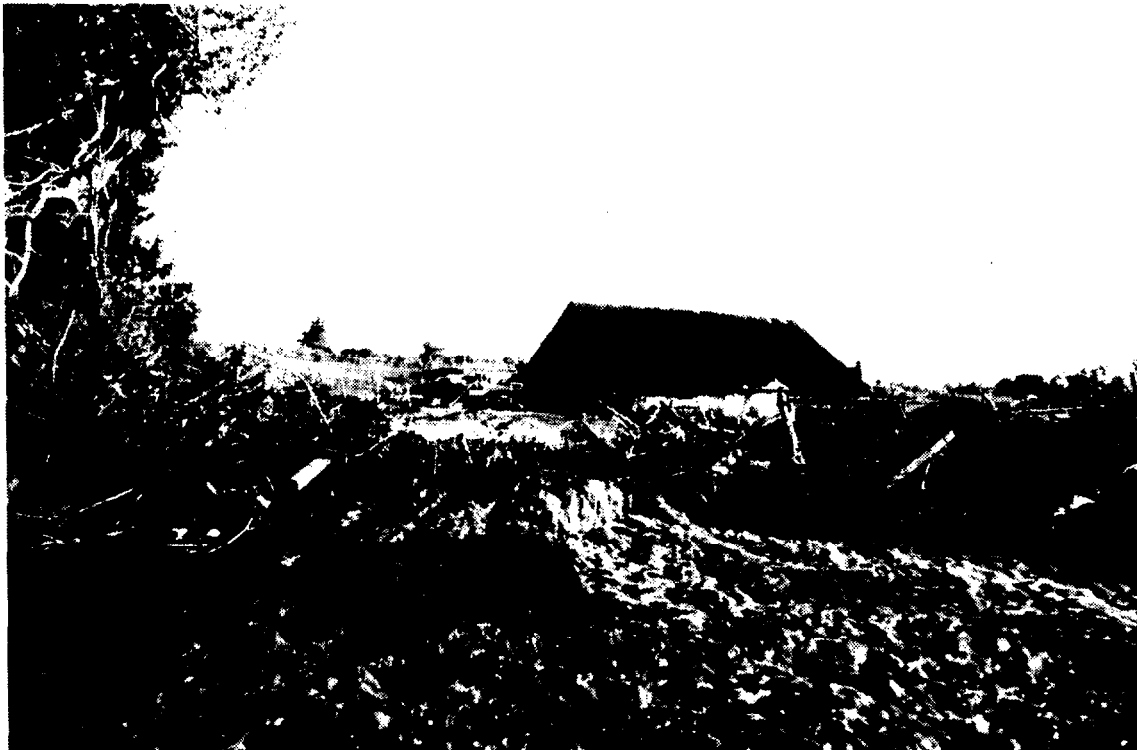
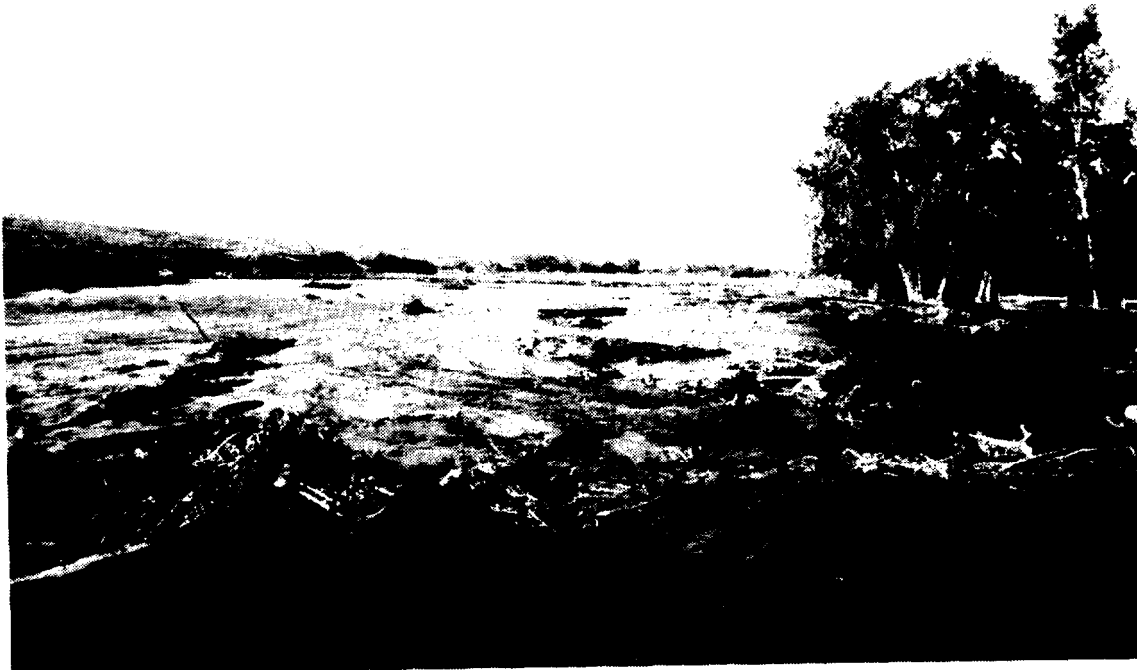
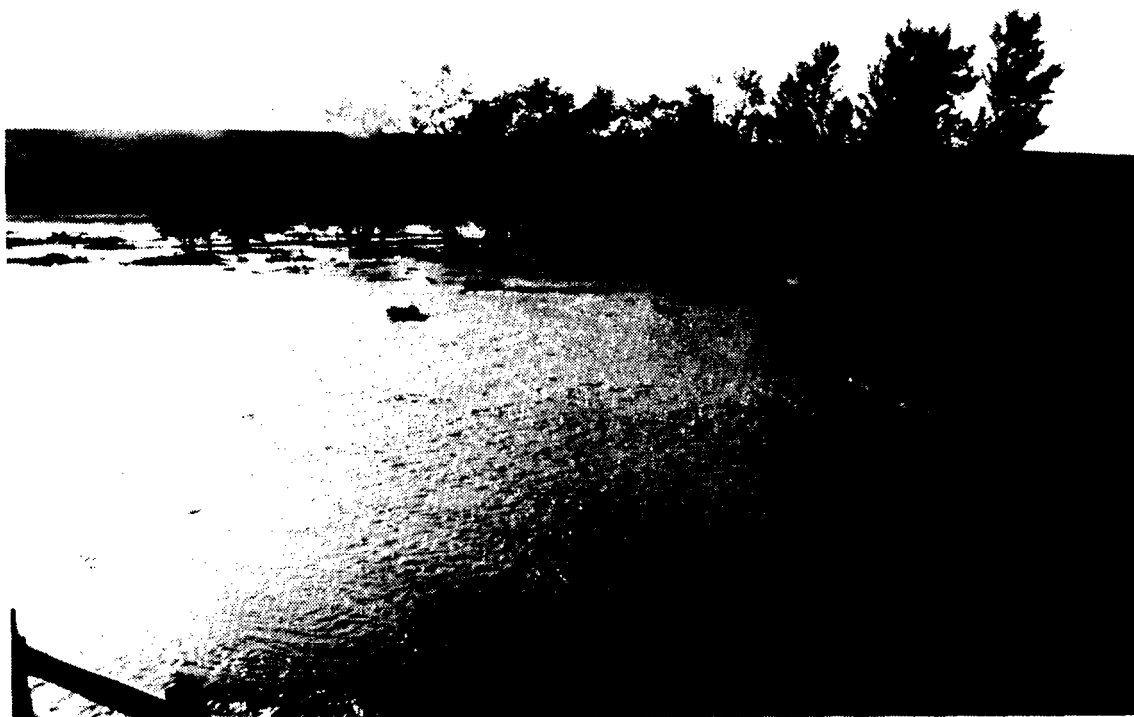
Figure 18. Flooding on Birch Creek Gambill property the day after peak flows, May 1991.

Figure 19. Flooding on Birch Creek Gambill property the day after peak flows, May 1991.

Figure 20. Flooding on Birch Creek Gambill property the day after peak flows, May 1991.

Figure 21. Flooding on Birch Creek Gambill property the day after peak flows, May 1991.

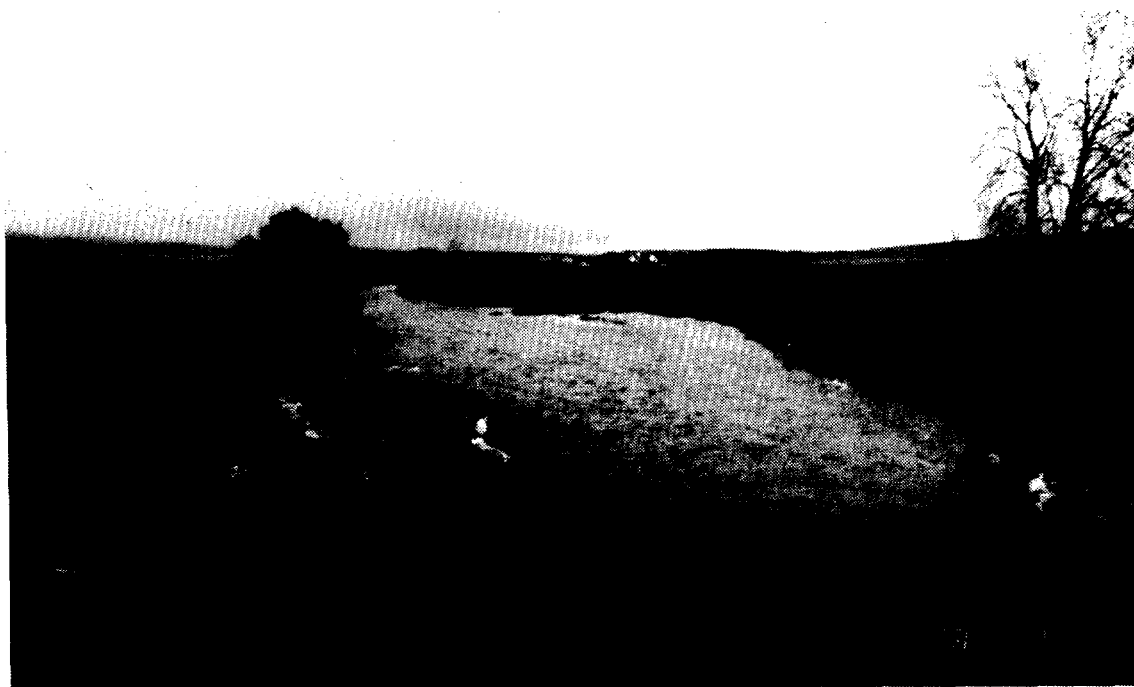
Figure 22. Photopoint 2 on Birch Creek **Hemphill** property displaying average spring flow, March 1989.

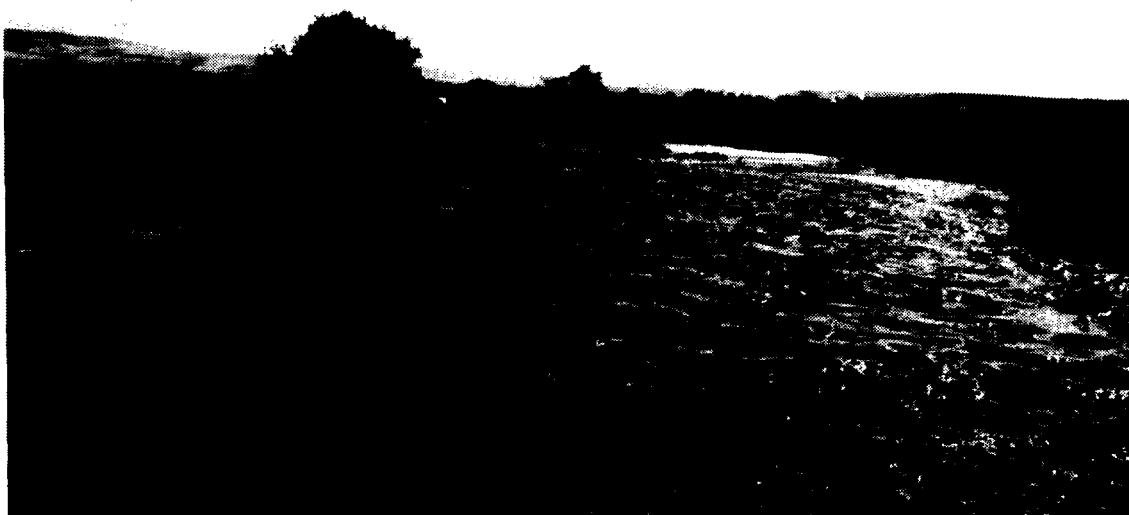
Figure 23. Photopoint 2 on Birch Creek **Hemphill** property the day after peak flows, May 1991.

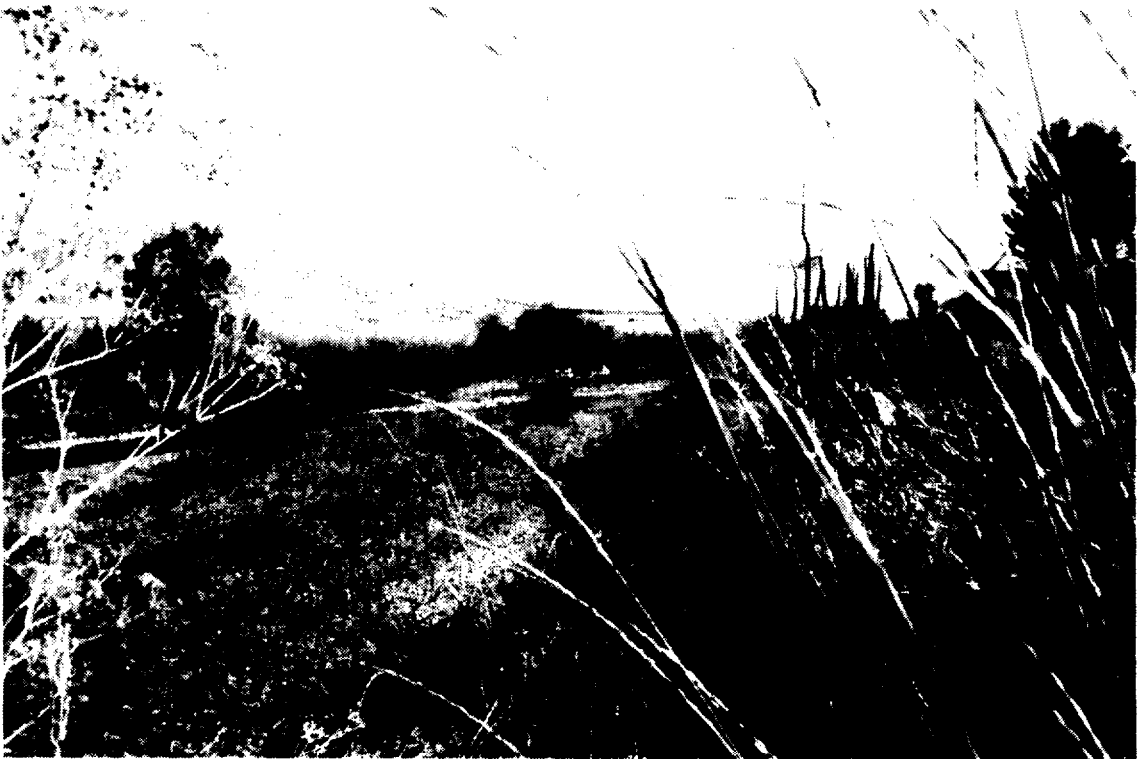
Figure **25**. Photopoint Ib on Birch Creek **Rhinhart property**, October 1991 displaying scour from May 1991 flood.

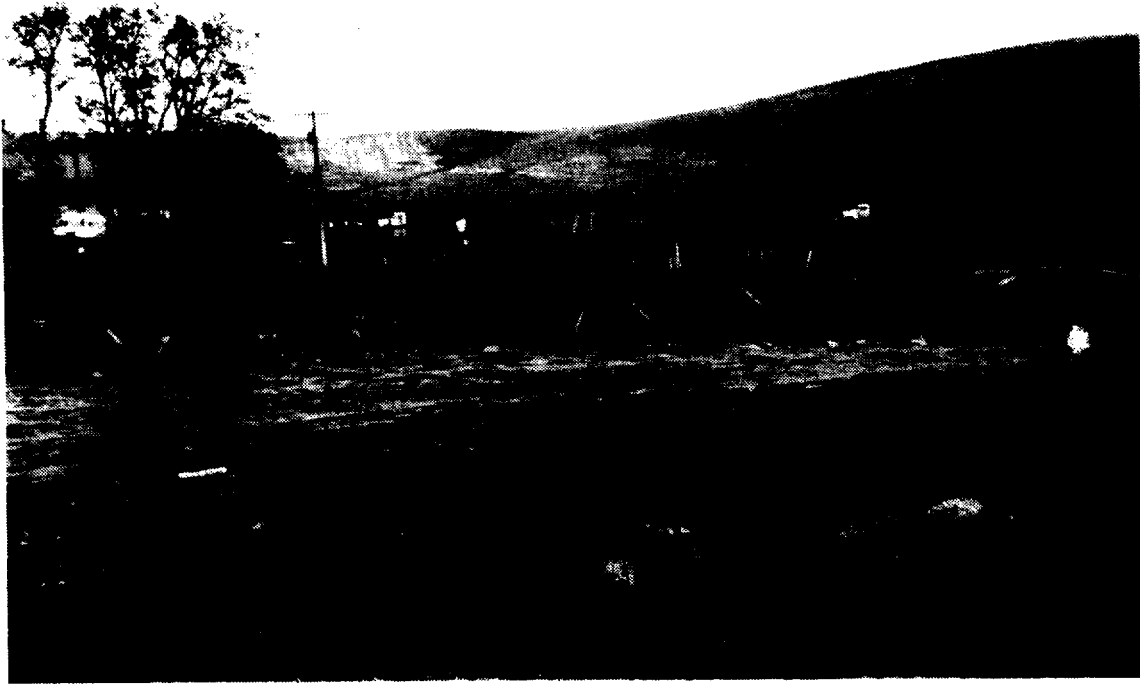
Figure 26. Damage to riparian corridor fencing on the Birch Creek McDaniel property resulting from the May 1991 flooding.

Figure 27. Damage to riparian corridor fencing on the Birch Creek McDaniel property resulting from the May 1991 flooding.

As a result of flooding, 1.2 miles of riparian corridor fence was destroyed. At the end of this report period approximately 0.5 miles of this has been rebuilt. The remaining 0.7 miles has been temporarily replaced with electric fencing until it can be replaced in the spring of 1992.

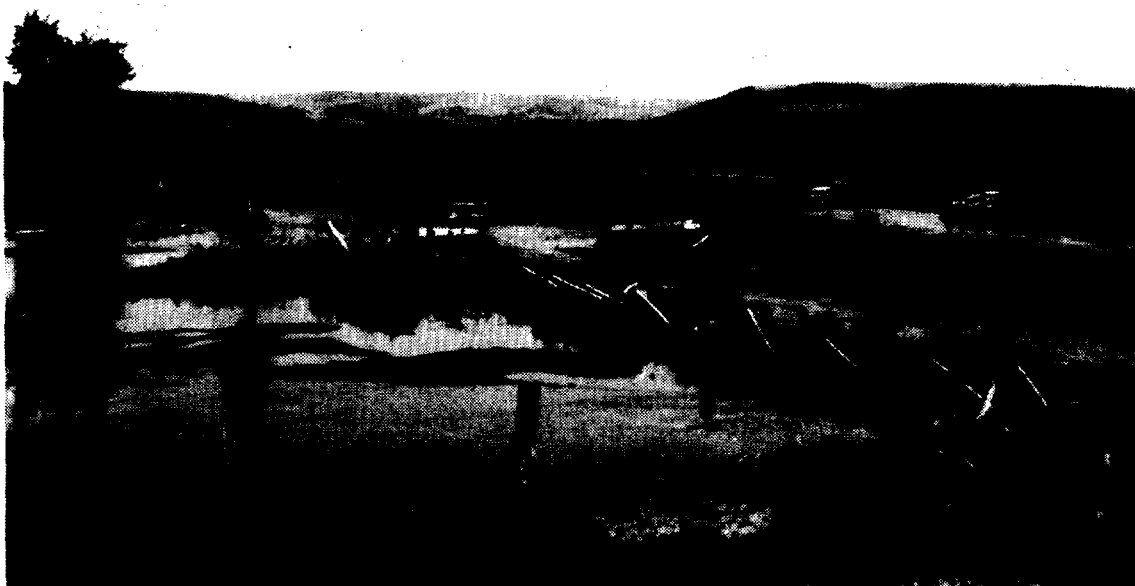
Figure 32. Damaged watering gap and riparian corridor fencing on Birch Creek F. Straughan property the day after peak flows of May 1991 flooding..

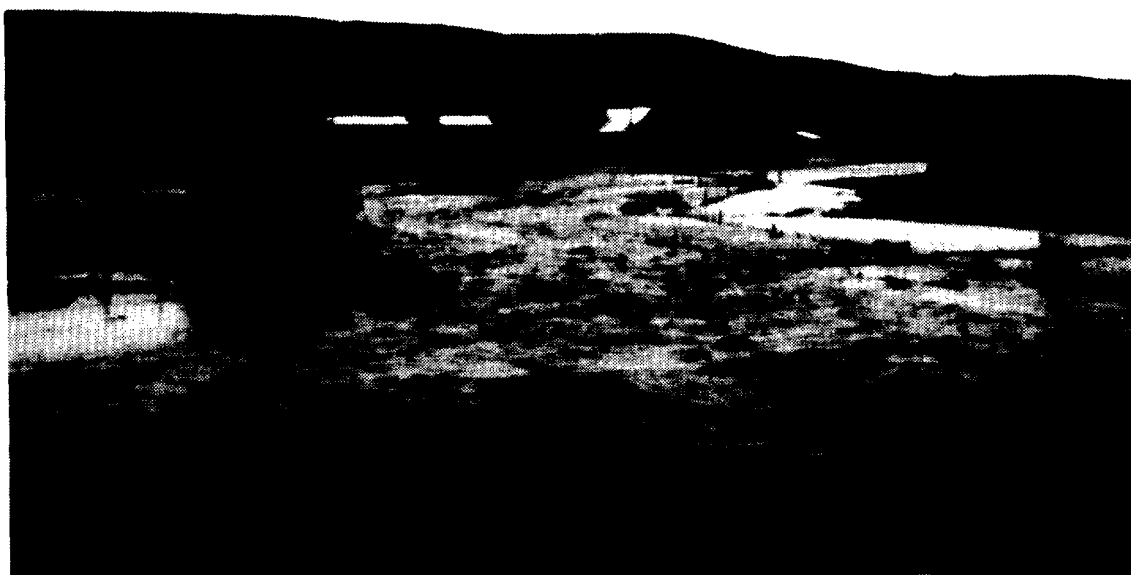
Figure 33. Birch Creek F. Straughan property several hours before peak flow of May 1991 flood.

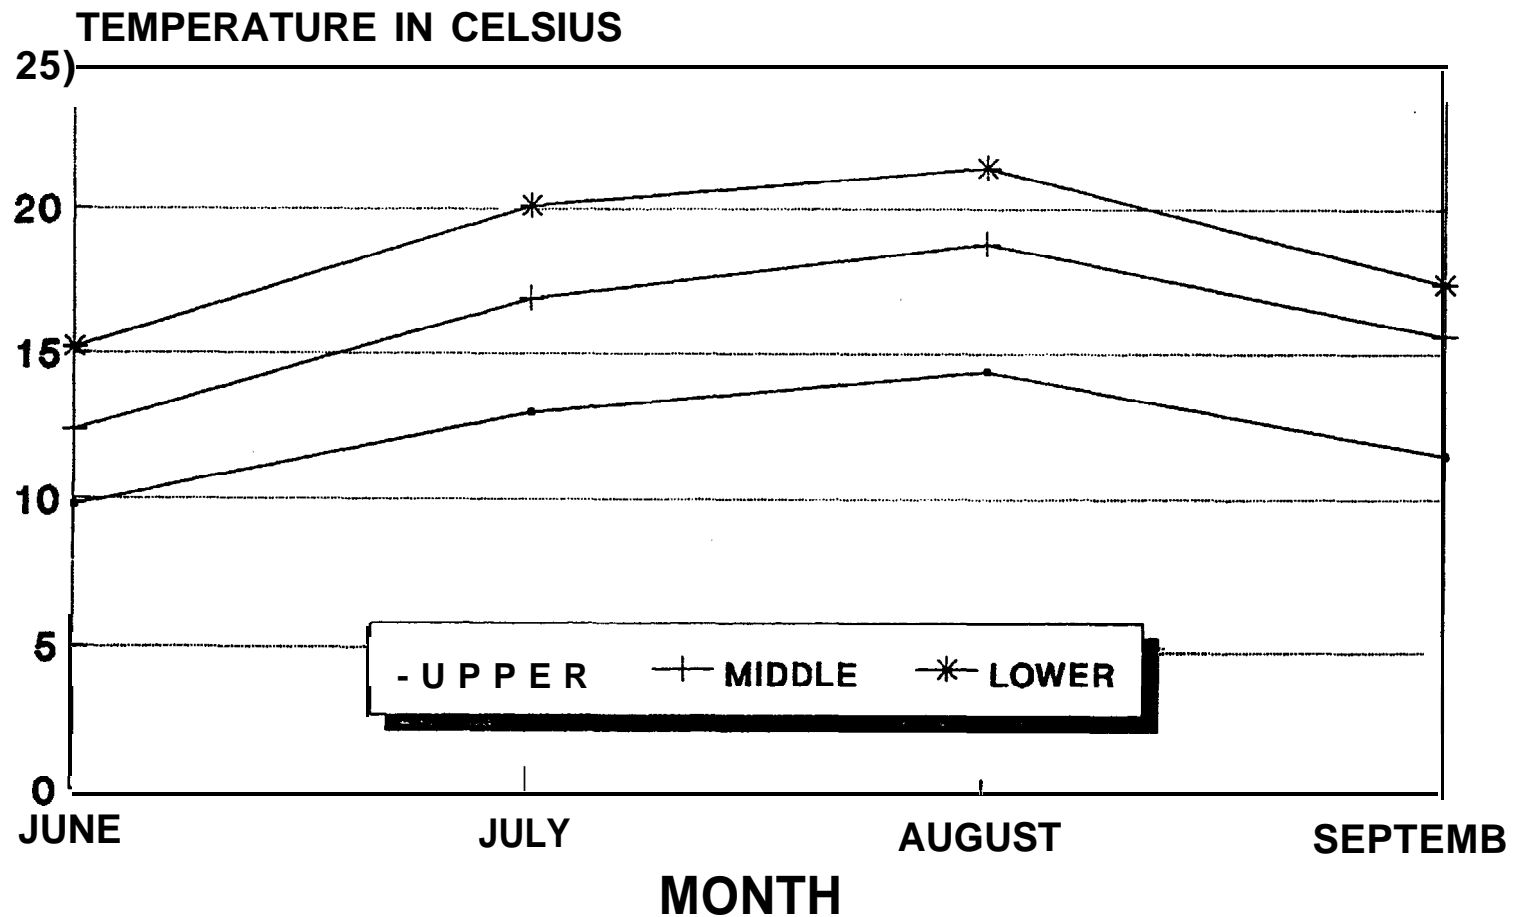
EAST BIRCH CREEK MONTHLY MEAN TEMPERATURE

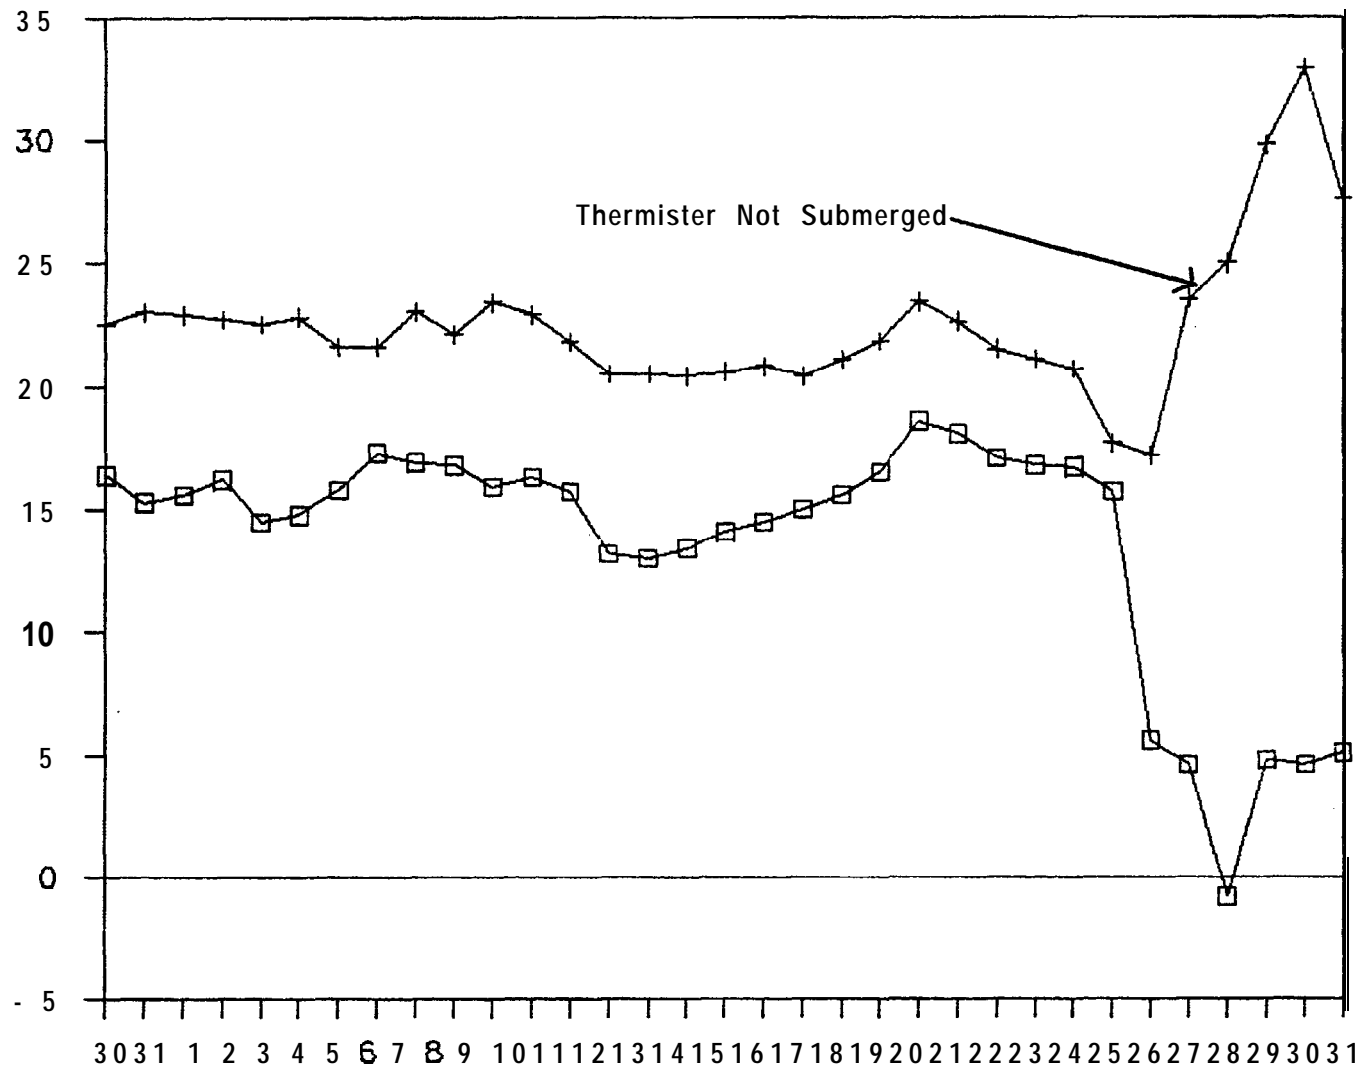
LOWER MEACHAM/LP

JULY 30 - AUGUST 31

TEMPERATURE IN CELSIUS
